SEDWICK HOUSE

ca.18000

INVENTORY FORM FOR STATE HISTORIC SITES SURVEY

HISTORIC AMERICAN BUILDINGS SURVEY
INVENTORY CT-53

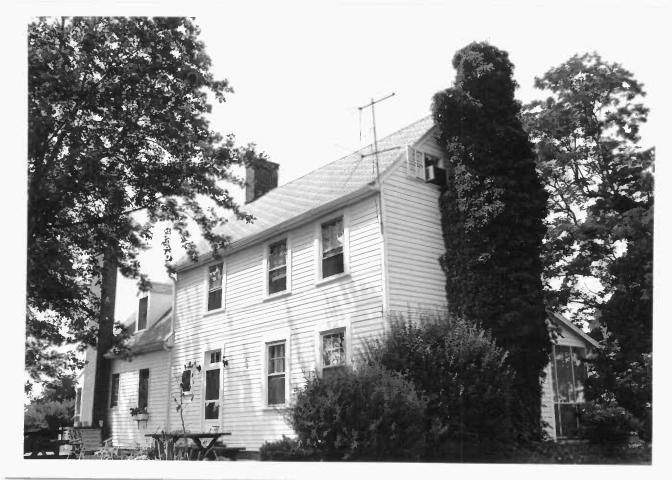
CLVT-63 Sedwick House N.E.

At each end of this two story three bay frame farmhouse stands a single chimney. One, on the exterior, has stepped weathering and a free standing stack; the other is enclosed within the end wall of the structure. At one end stands a one and one half story frame addition.

This is a simple C. 1800 farmhouse. It is 2-1/2 storys in height and 3 bays wide with a smaller addition which telescopes into the main house. The exterior brick chimney at the end of the main house is separated from the wall above the second story level.
